The 2nd International Conference on Rehabilitation and Maintenance in Civil Engineering

Some Common Maintenance Problems and Building Defects: Our Experiences

^aProperty Division, Social Security Organisation (SOCSO), Malaysia

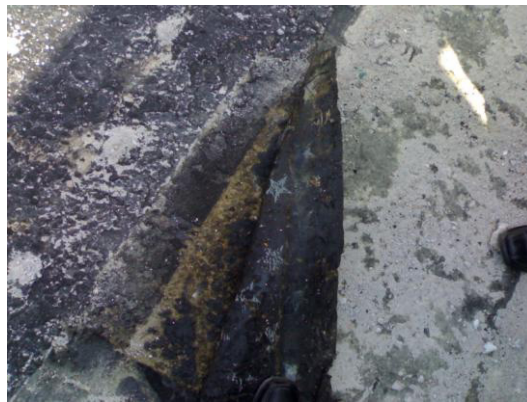
Figure 1 and Figure 2 show the condition of defective waterproofing system at some of SOCSO buildings.

From the above, the bituminous membrane causes regular problem which we identified its root causes as follows:

- The burning process of membrane was not properly carried out resulting weak bonding to the substrates. Water may have tracked between the membrane and the slab thus makes it difficult to trace the source of the leak.
- No screed to protect the membrane from punching forces.
- Failure to repair minor defects at early stage that escalated to become major.

Figure 1. Failed Torch-on Membrane at SOCSO Seberang Jaya Office.

Some problems could have been avoided much earlier if the installer strictly followed the instruction such as constructing angle fillet at corners, fully cleaned the substrate surface prior to installation, accurately mixed component A with component B, etc. Our record shows that a 4 mm thick membrane performs better if compare to that of 3 mm. The reason being that the burning process is more 'stable' and easier resulting better bonding to the slab. Our records also concede the fact that flat roofs are usually more vulnerable to leakage problems compare to that of pitched roof (Douglas and Ransom, 2006).

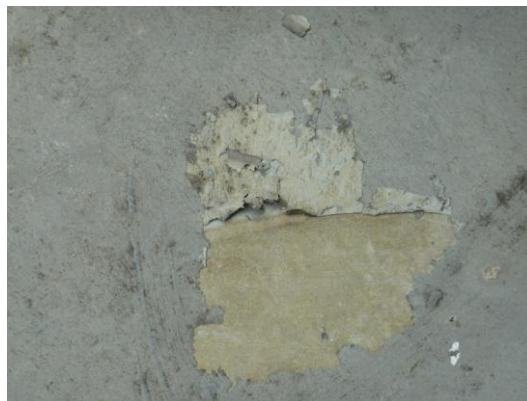
Figure 2. Damaged Liquid-Type water proofing layer at SOCSO Melaka Office.

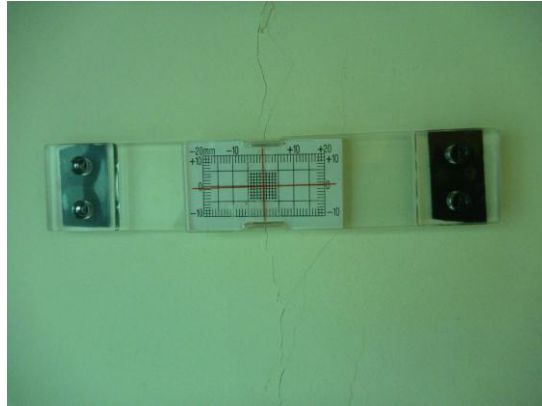
A typical crack of buildings in Malaysia is of non-structural type i.e. shrinkage cracks, joint cracks, etc. Surface cracks are commonly found on the floor screed and normally caused by improper curing process. Joint cracks are commonly seen at the joint of different structural elements such as column / brick wall and beam / brick wall. The common causes of such cracks are identified due to the difference thickness of plastering on those structures and insufficient bonding element that holds bricks to the column or beams. Other area of cracks is around the opening such as for windows and doors. These kinds of crack can be repaired easily with straight forward methods such as applying repair mortar / putty onto the affected area (for cracks < 3mm) together with suitable wire meshes provided the surface preparation is carried out in proper ways. In some cases, corrosions of steel reinforcement were detected and these incidents indicated that immediate repair was not carried out at early stage. The measurement of crack progress was carried out using crack gauge to ensure no further crack movement prior to the repair works. Figure 3 shows a crack gauged installed on the wall of our office to measure the crack progress (SOC SO Maintenance Report For August ,2011).

Figure 3. Measurement of cracks by using crack gauge plate.

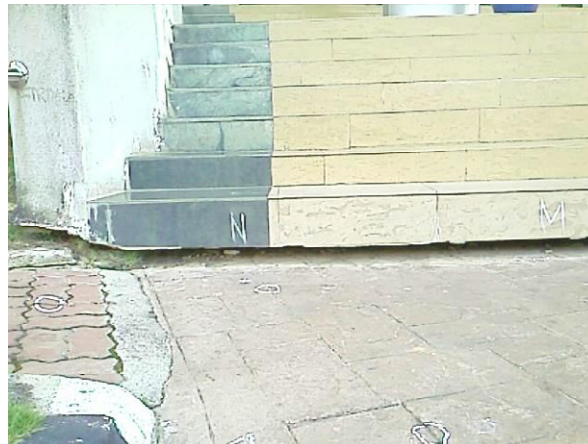
In some swampy areas in Malaysia, soil settlement is critical to buildings and infrastructures. For SOCSO buildings, the most affected areas are building aprons, retaining walls, perimeter roads and fencings. In one of the remedial works carried out at SOCSO building in Penang, a slab lifting method was used where a special resin was injected into the ground at various levels so that it mixes and improves the soil properties. For area of approximately 300 m², it took 5 days to finish which is much faster compare to other method despite its higher cost that the client had to bear. After 2 years of the treatment, the recorded settlement was 3mm and considered acceptable (SOCSO Maintenance Report For January 2011). Figure 4 and Figure 5 show the improvement before and after the treatment whilst Table 2 indicates the properties of the resin used.

Figure 4. Soil settlement before treatment.

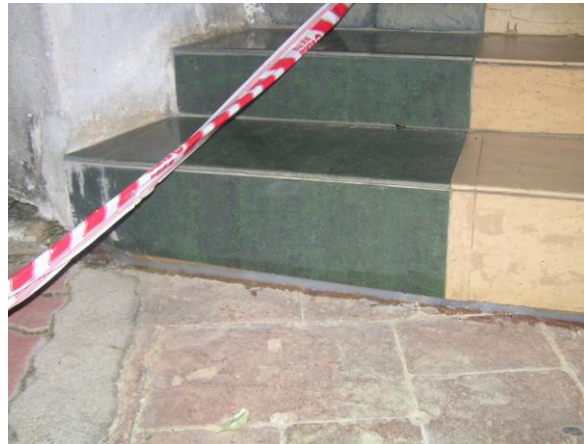
Figure 5. After treatment.

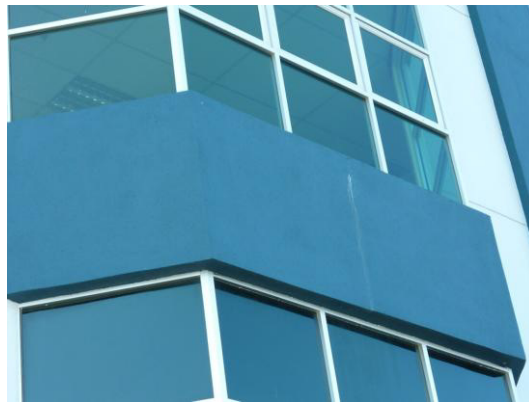
Most of the finishes of facade for SOCSO buildings are of plaster and paint except for SOCSO Kuala Lumpur which is of aluminium cladding. It is common to see that the wavy surface of plaster due to poor workmanship. Since this problem is common in Malaysia, SOCSO decided to have the external walls of the new buildings roughen with mortar prior to painting. With this kind of finishes, the texture could hide the uneven plastering surface on the large surface. The only problem is that repair of the surface should any defects occur would be a bit more difficult. Another issue with the external wall is an efflorescent (whitish bleeding) spotted on the wall surface which occurred due to chemical reaction of the wall materials and high moisture content on the wall prior to painting process. This problem can be resolved by completely removing the finishes on the affected areas and subsequently repainted it in the suitable condition. Figure 6 shows an efflorescent problem encountered on the external wall of SOCSO office in Kedah (northern part of Malaysia) (SOCSO Maintenance Report For May 2011).

Figure 6. An efflorescent signs.
